Manhole Inspection Summary

Manhole # S35SS_011MH

Insp Date: 1/12/07 11:43 AM

Location Address: **2722 GUILFORD AVE**

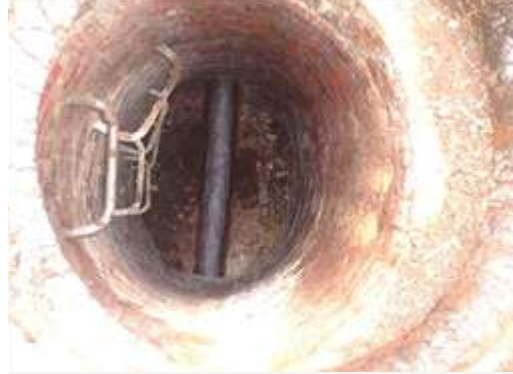
Top View

Bench debris.

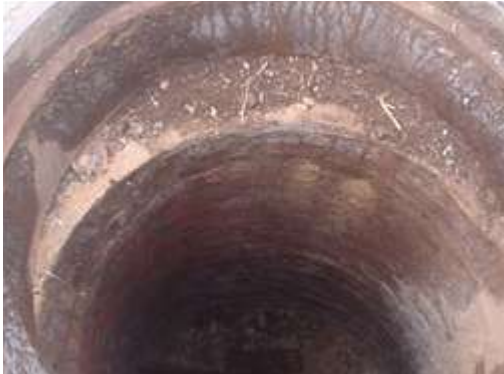
Defect

Frame Offset: **3** (in.) Condition: ☒ Sound ☐ Cracked ☐ Leaks

Infiltration: ☐ None ☒ **Joint** ☐ Cracks ☐ Mortar ☐ Roots ☒ **Wall**

Infiltration: ☐ None ☐ Joint ☐ Cracks ☒ **Mortar** ☐ Roots ☒ **Wall**

Frame offset. Adjustment and Barrel infiltration.

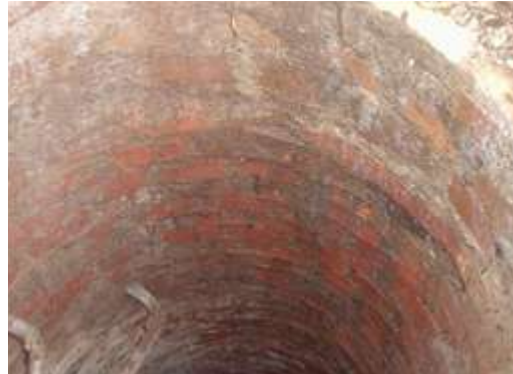
Defect

Frame offset. Adjustment and Barrel infiltration - other side.

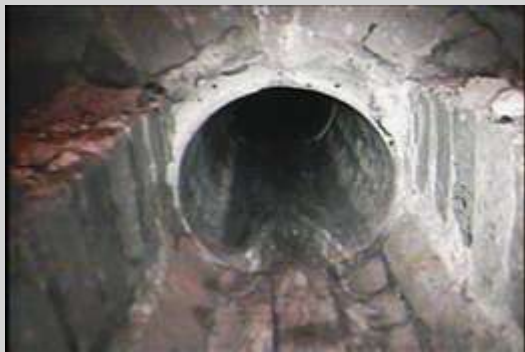
8 in. Circular Gravity Sewer Pipe Out @ 12 O'Clock

Rod and Bar (Angled)

Pipe Material: **Clay** ☐ Pipe Lined

Invert Depth: **10.63** (ft.) Flow Characteristics: **Fast**

Deposits: ☒ None ☐ Mud ☐ Sludge ☐ Debris ☐ Grease

Infiltration: **None** Pipe Seal Cond: **Unknown**

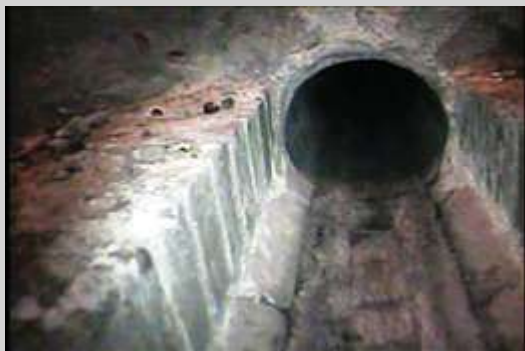
8 in. Circular Gravity Sewer Pipe In @ 6 O'Clock

Rod and Bar (Angled)

Pipe Material: **Clay** ☐ Pipe Lined

Invert Depth: **10.54** (ft.) Flow Characteristics: **Fast**

Deposits: ☒ None ☐ Mud ☐ Sludge ☐ Debris ☐ Grease

Infiltration: **None** Pipe Seal Cond: **Unknown**
